INTENSIVE-LEVEL ARCHITECTURAL SURVEY

WHEELER STREET AND OAKCROFT RESIDENTIAL AREAS

Township of Montclair, Essex County, New Jersey

OAKCROFT RESIDENTIAL AREA SUPPLEMENT

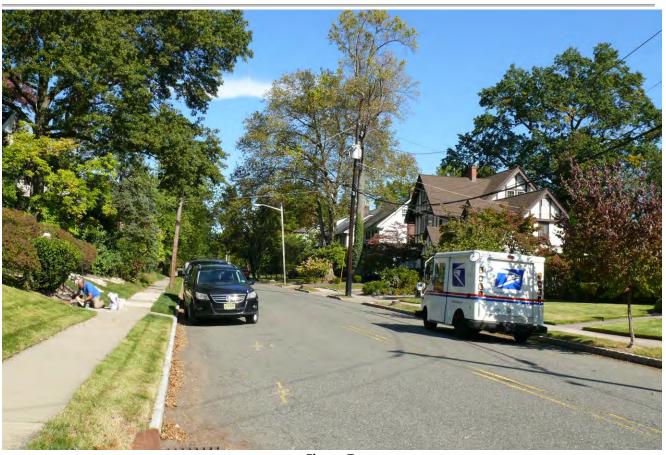
Figure 7

View looking north along Princeton Place at the intersection with Godfrey Road.

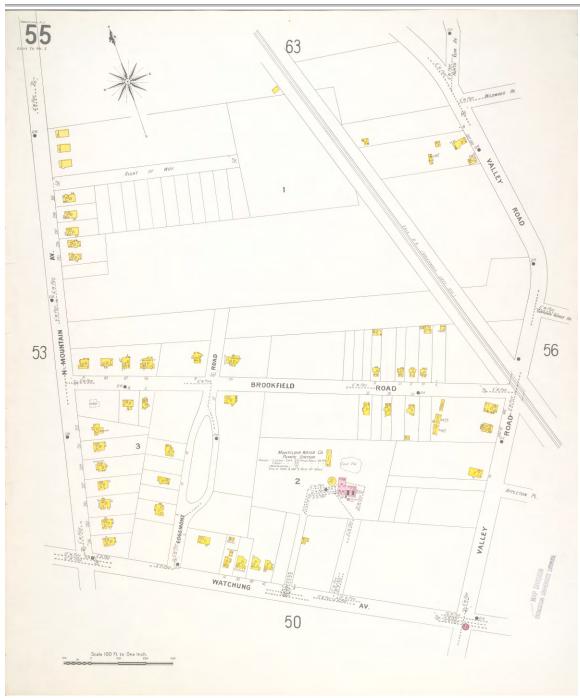
Figure 11

1907 Sanborn Fire Insurance Maps (Sheet 53) showing the Oakcroft Residential area just prior to development. (Credit Sanborn Map Company. *Sanborn Fire Insurance Maps, Essex County, Vol. 3.* New York, NY: Sanborn Map Company, 1907. Sheets 53. (Available from the Internet: Library.Princeton.Edu)

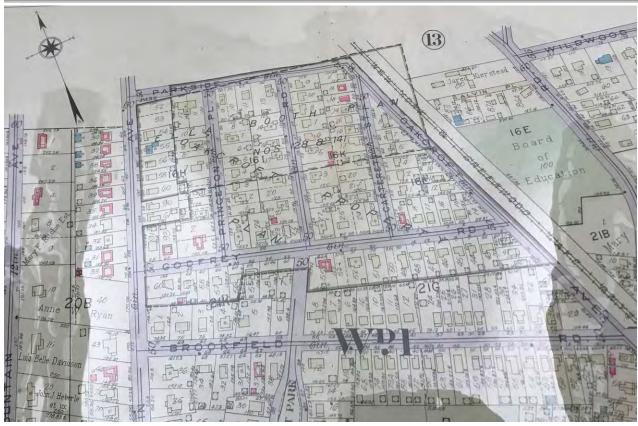
Figure 12

1933 Real Estate Atlas of Montclair showing the Oakcroft Residential area just after approximately twenty-five years of consistent development. (Credit: Franklin Publishing Co. *Real Estate Atlas of Montclair, Glen Ridge, Cedar Grove & Verona, NJ*. Philadelphia, PA: Franklin Survey Co., 1933. (Montclair Public Library, Main Branch)

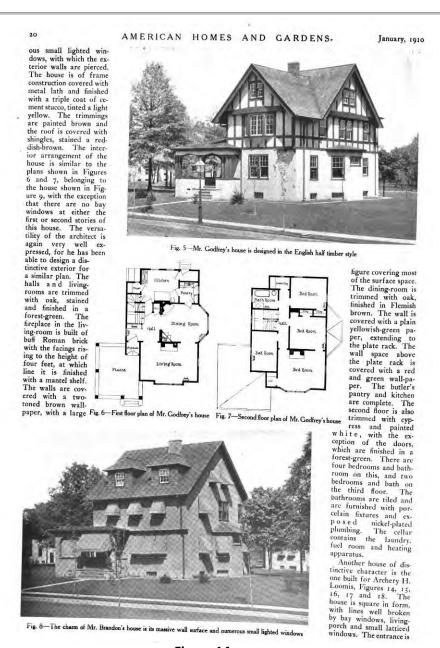
Figure 14

An excerpt from 1910 article in *American Homes and Gardens* about some of the first residences constructed in Oakcroft that were designed by the architectural firm, Freeman and Hasselman of New York. The images here are of 19 Princeton Place, which was constructed for William J. Brandon, a dry goods merchant in New York.
