TOWNSHIP OF MONTCLAIR

WATCHUNG PLAZA
HISTORIC BUSINESS DISTRICT
NOMINATION REPORT

SEPTEMBER 2012

RICHARD GRUBB & ASSOCIATES, INC.
Cultural Resource Consultants

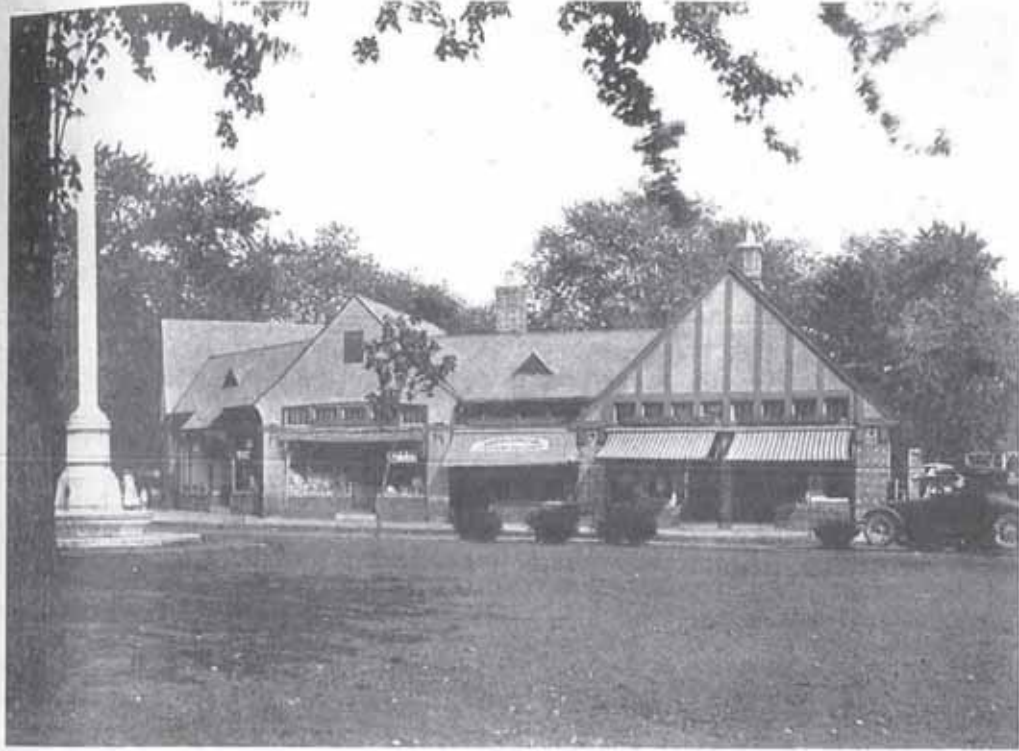
VILLAGE STORE GROUP, WATCHUNG, (MONTCLAIR), N. J.
CLIFFORD C. WENDEHACK, ARCHITECT

Clifford C. Wendehack, Village Store Group, Watchung (Montclair), N.J. (from The American Architect 1925).

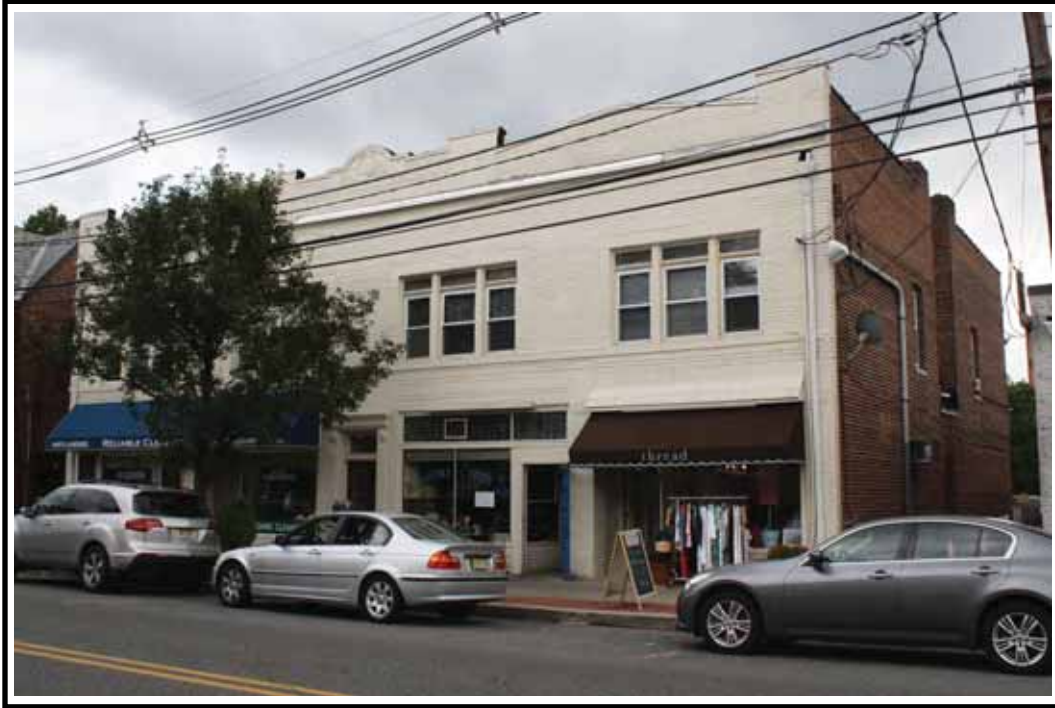
Plate 4.4:

123 Watchung Avenue. Although the exterior of this building has been painted, the patterned brickwork is still evident. The second storefront from the right, which presently houses the Bluestone Coffee Co., is particularly well-preserved.
Photo direction: Southeast
Date: September 20, 2012
Photographer: Jennifer B. Leynes

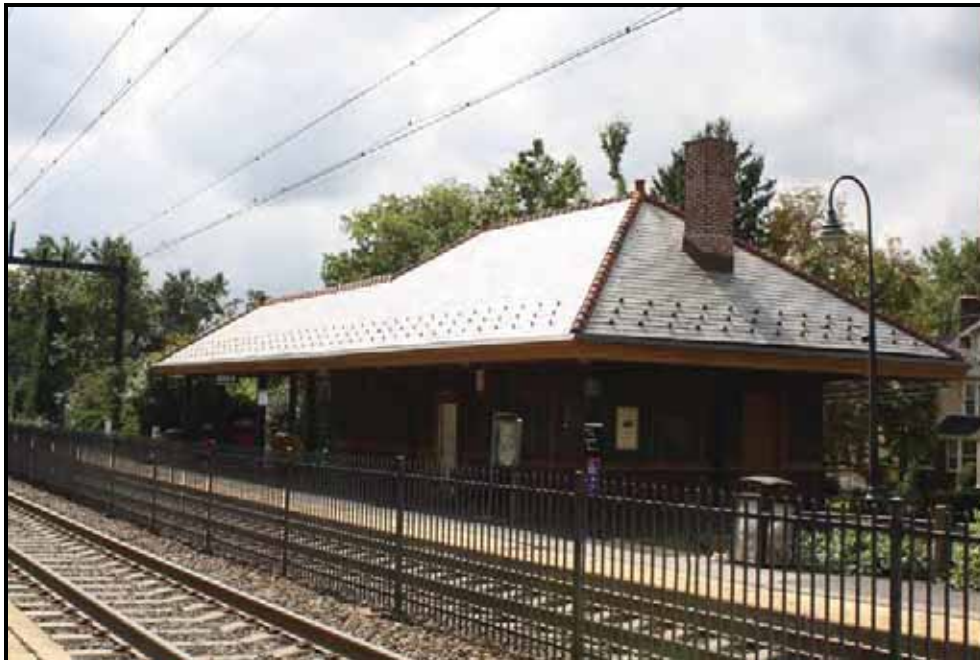
Architectural Description: This one-story railroad station has a hipped roof with wide overhang. The slate roof has terra cotta tiles on the ridges and extends out from the building to cover the platform; it is supported on squared wood posts. The foundation is embanked and constructed of stone laid in irregular courses. The lower walls are clad in clapboard with shingles above. The building has paneled wood doors with diamond-pane transoms and large windows with diamond panes in the upper sash. A bay window at the south end of the east elevation contained the ticket office. A brick chimney is located on the north roof slope. Stairs on the north and south ends of the building provide access from street level; both the stairs and platforms have pipe railings.

History: The Watchung Avenue Station was constructed in 1903-1904 by the Erie Railroad to replace an earlier station located on the east side of the tracks.

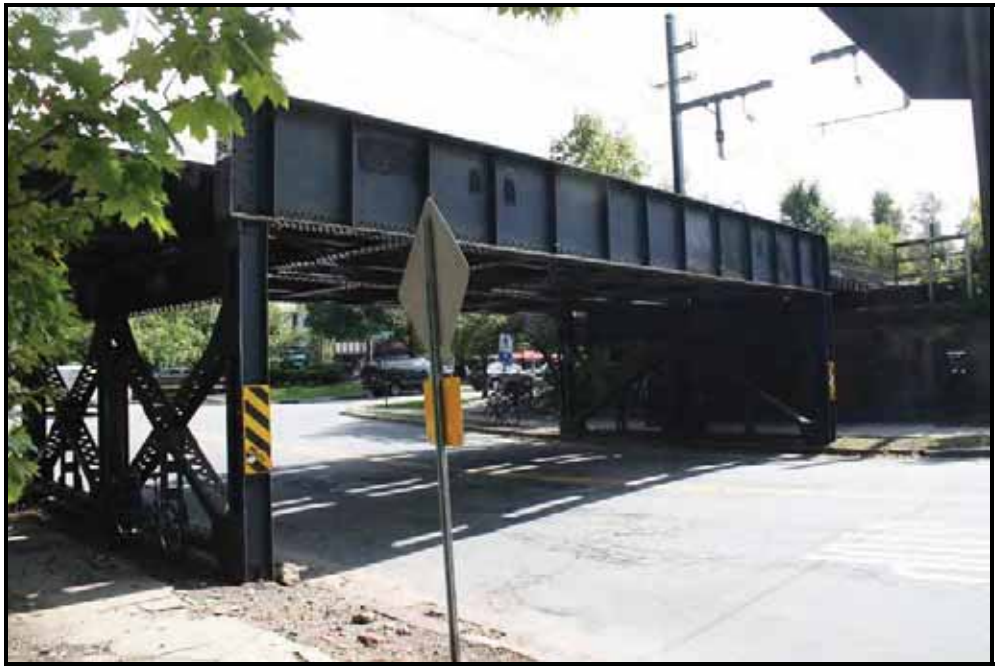
National Register: _____ State Register: _____
 Present Use: Bridge Historic Use: Bridge
 Engineer: Unknown Year Built: 1900
 Type: Girder Spans: 3
 Material: Steel Physical Condition: Fair

History: The NJ Transit Bridge over Park Street was constructed in 1900 as part of a grade separation project in the Watchung section of Montclair. The construction of the bridge and realignment of Park Street necessitated the removal of the existing railroad station on the east side of the tracks. The station was replaced in 1903-1904 by the existing Watchung Avenue Station (see Inv. No. 1).

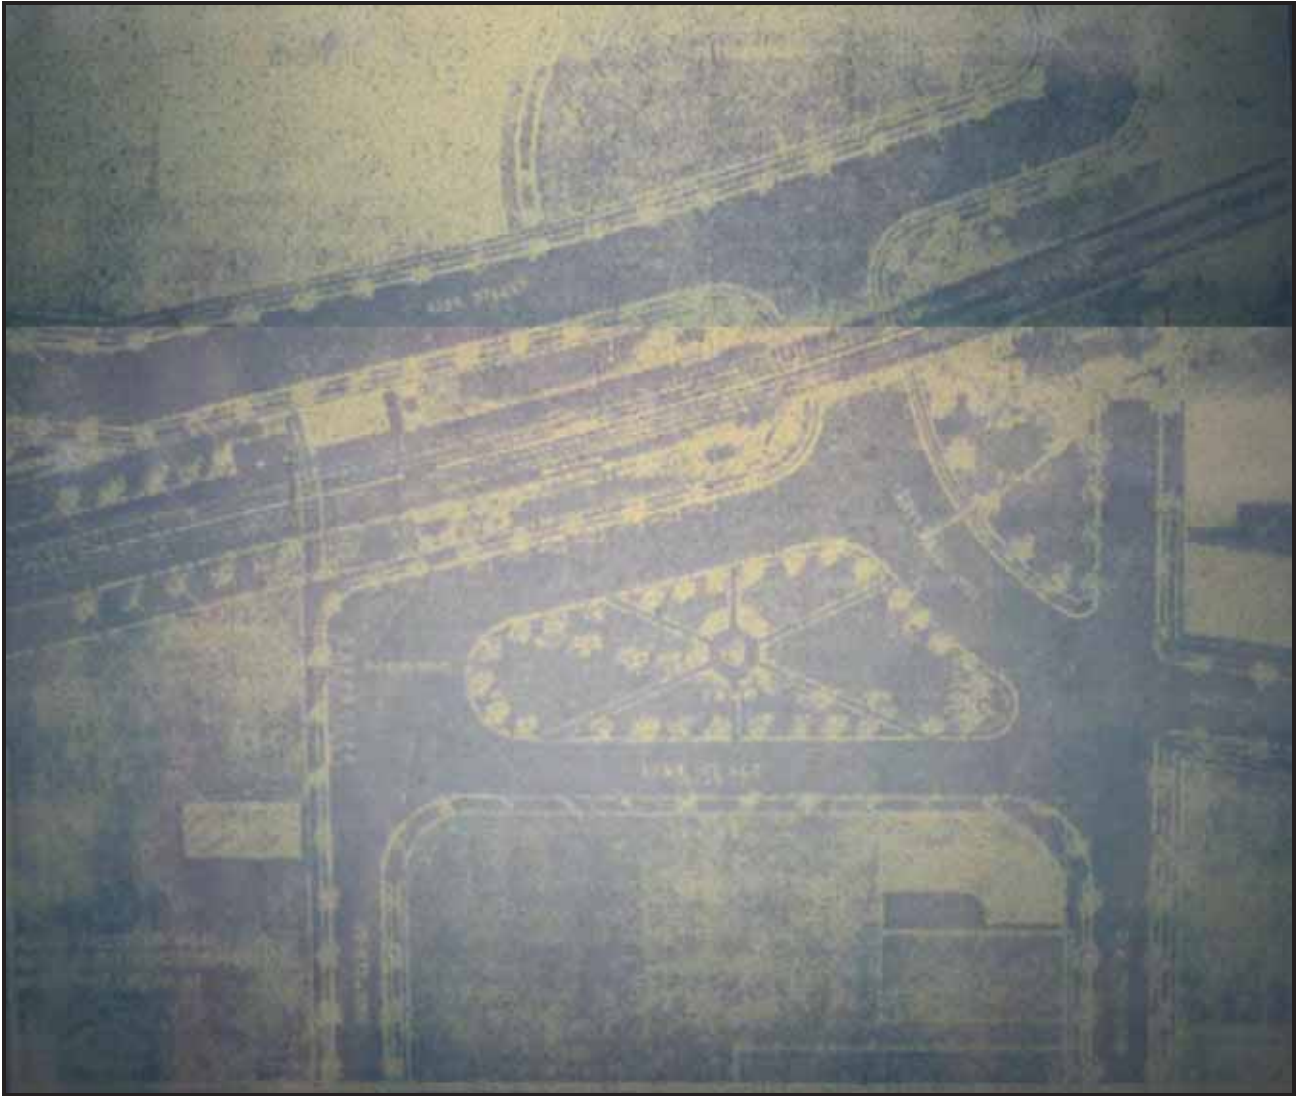
1918 Plan for Watchung Avenue Station Plaza by Clifford C. Wendehack (from *Montclair Times* 15 June 1918).

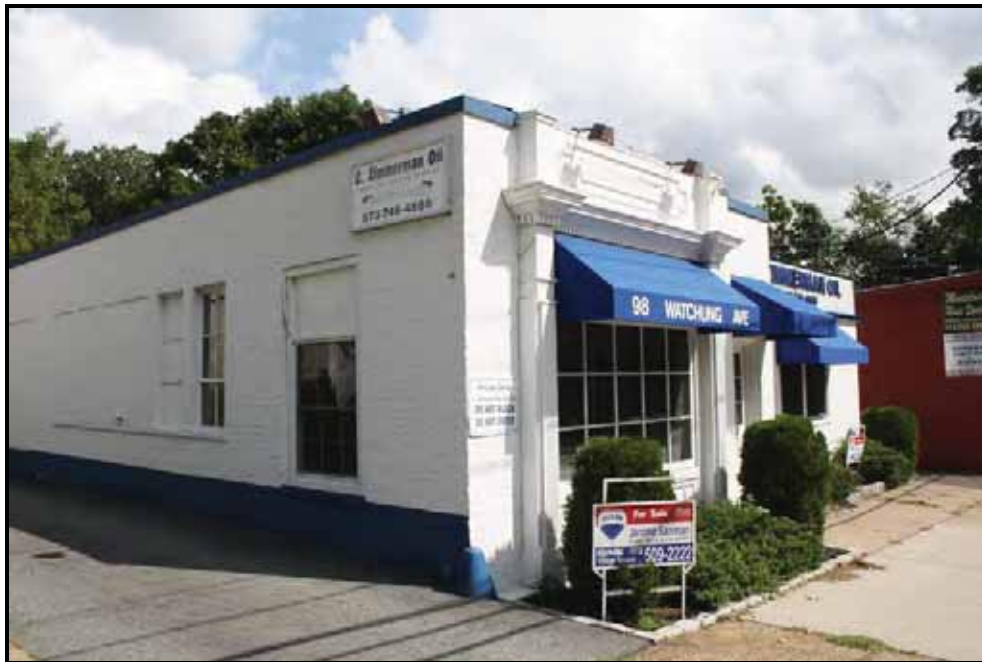
Architectural Description: This one-part commercial block has a brick exterior and flat roof; a concrete block addition is located on the east elevation, built c. 1970 to replace an earlier canopy. The main block has an offset replacement door and a large, multi-light display window with wood bulkhead. The display window has a stylized Classical surround with fluted pilasters supporting an entablature featuring a molded architrave with dentils and a wide frieze with a central panel. The addition has a central paired window with replacement sash. The parapet on the façade of the addition has been covered with a metal sign, but the original wood panels are visible on the east elevation. A large one-story garage with shed roof was constructed c. 1975 at the rear of the property.

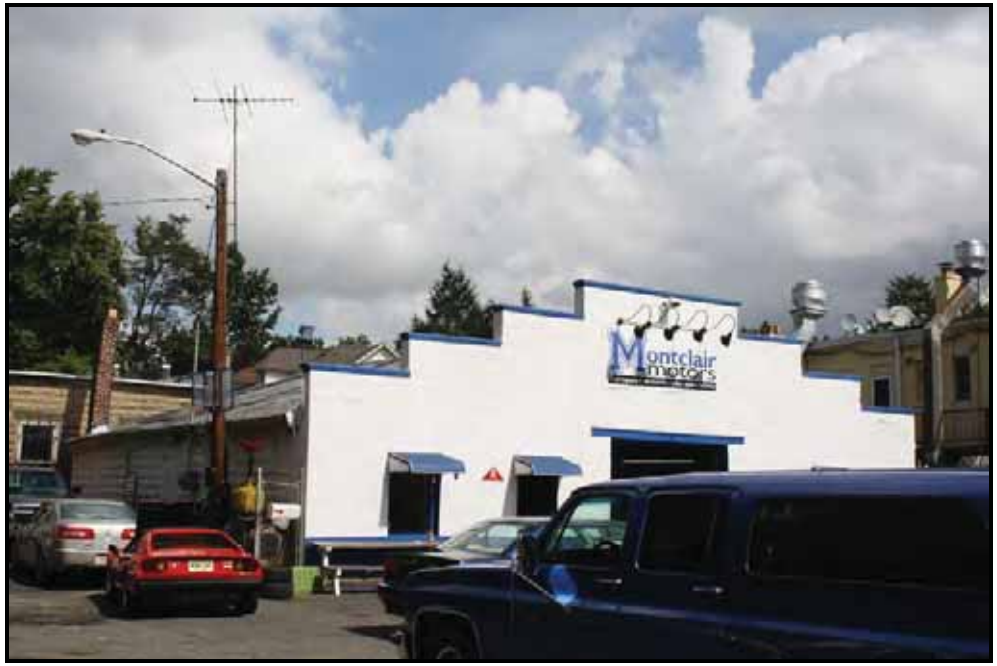
Architectural Description: This one-story garage has a gable roof with stepped parapet. The building is constructed of rusticated concrete block, and the façade is covered in stucco. A replacement garage door is centered on the façade and flanked by a window and door on the west and a single window on the east.

History: This garage was the first commercial establishment constructed in the Watchung Plaza Historic Business District. Tax records indicate that the building was constructed in 1906, and the 1910 city directory includes a listing under “Automobile Dealers and Repairers” for William and Henry Bennett on Watchung Avenue at the corner of Park Street (Montclair Tax Assessor 2012; Price and Lee Company 1910).

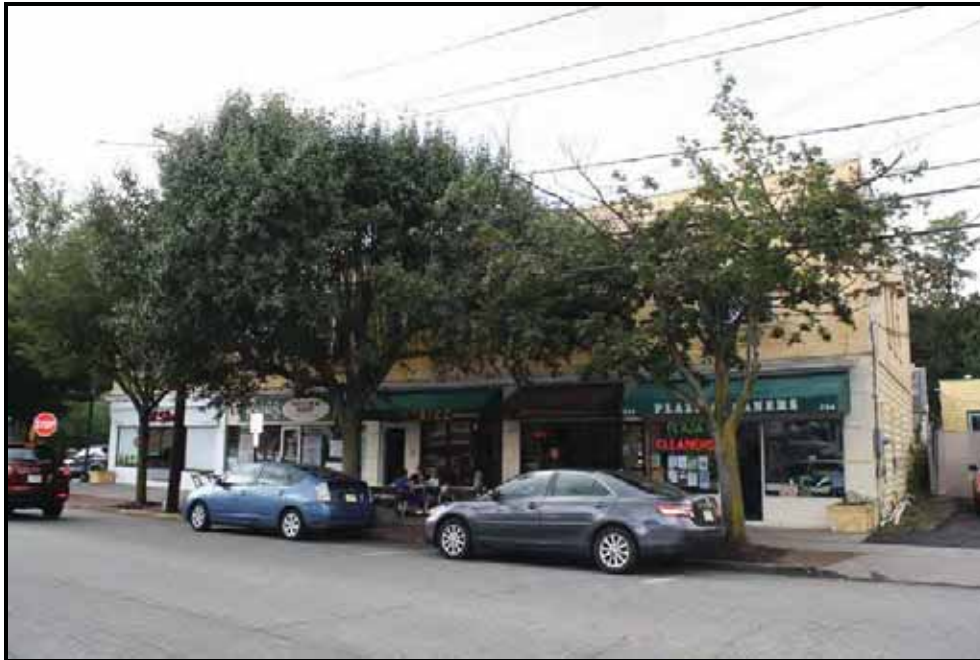
Architectural Description: This two-part commercial block contains five stores at street level and residential units in the second story. The building has a stucco exterior and a parapet wall with a wood cornice and paired decorative brackets. The upper floor has paired replacement sash windows with stuccoed lintels and sills. The storefronts have all been modernized; however, the store at the south end (#250) retains the original recessed entry flanked by display windows and bulkheads with decorative panels. The storefronts are separated by pilasters comprised of 9 brick courses alternating with one rough-faced stone course. A wood cornice extends across the façade, above the storefronts. The first floor on the north and south elevations is constructed of rusticated concrete block. The rear has a modern exterior wooden staircase.

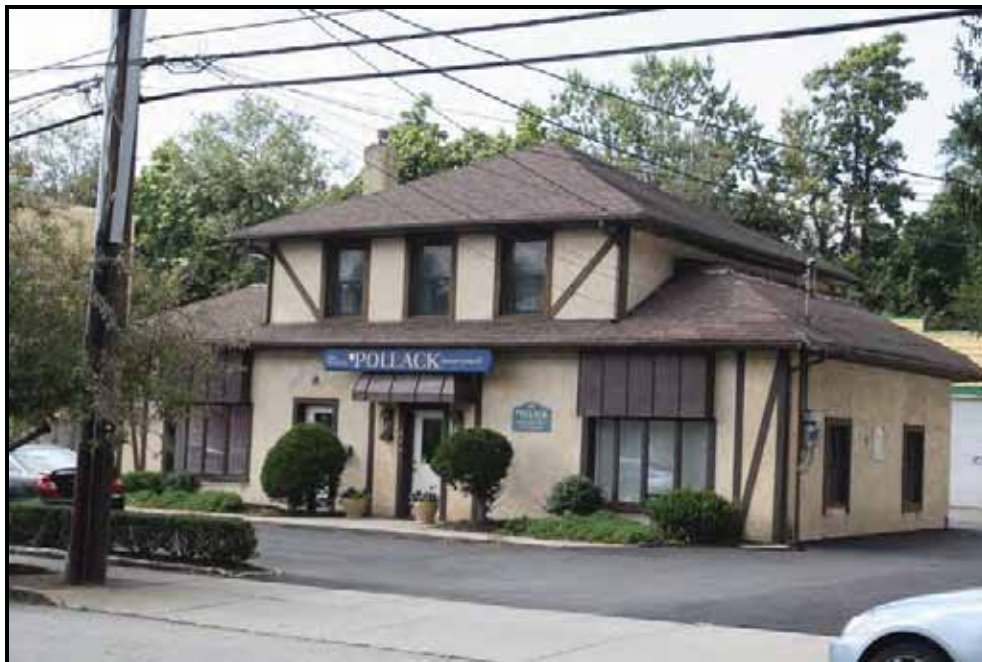
Architectural Description: This property includes two buildings: a Tudor Revival-style office in front, and a one-story garage in the rear. The office has a central two-story block with hipped roof flanked by one-story hipped wings. The building has a stucco exterior with decorative half-timbering at the corners. The altered façade has a central doorway and an offset door in the main block, and ribbons of four fixed windows in the wings. Historic maps indicate that the building formerly had a one-story canopy on the main block. The garage is constructed of rusticated concrete block and has a stepped parapet. The building has three large garage bays and four window openings.

History: A business known as the Park Street Garage was located at 256 Park Street as early as 1920 (Price and Lee Company 1920:402). The 1933 *Atlas of Montclair* indicates that a gas station and store with a canopy were located near the road, with a large garage at the rear of the property, its rear wall extending at an angle along the property boundary (Franklin Survey Company 1933). An insurance map published in the following year also shows the store with a one-story canopy; the building had a two-story central block flanked by one-story wings, as it does at present (Sanborn Map Company 1934). A gas station continued to operate here as least through 1965 (Sanborn Map Company 1965).

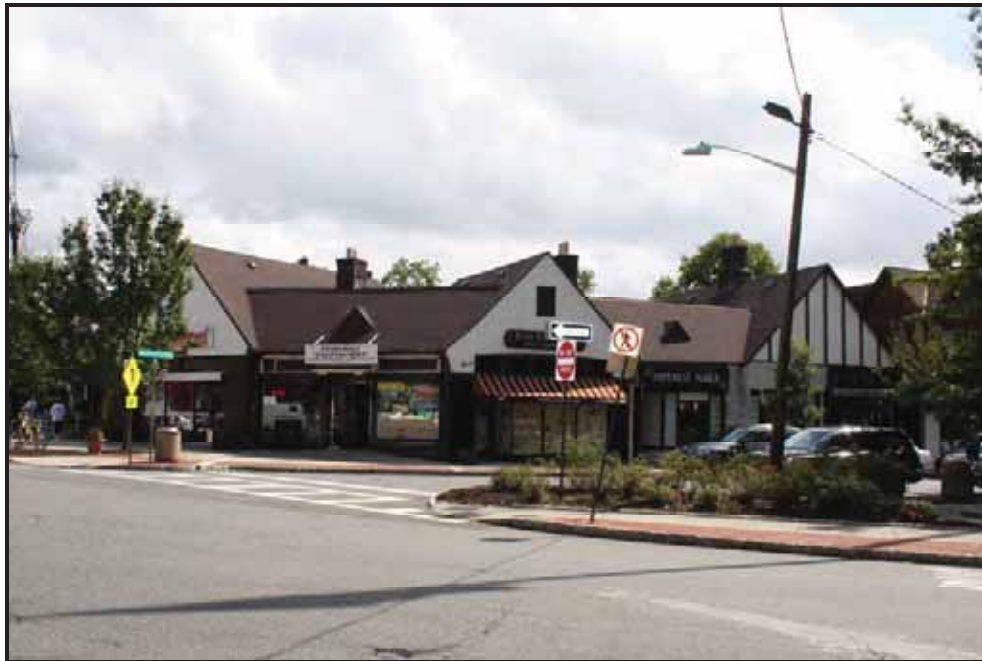
Architectural Description: This Tudor Revival-style, one-part commercial block fronts the corner of Watchung Avenue and Watchung Plaza and has a J-shaped footprint. The building has a side gable roof with three prominent cross gables. The central cross gable has an arched transom with replacement windows; the flanking gables originally had half-timbering and transoms comprised of eight, 6-light windows; however, the transoms have been partially enclosed, and the half-timbering has been removed in the north-facing gable. The side gable sections have blind gabled dormers and formerly had transoms, since enclosed. The roof features several prominent brick chimneys with terra cotta chimney pots. The building was designed as seven stores with a service passage on the east end; it now contains six modernized storefronts with varied materials and design.

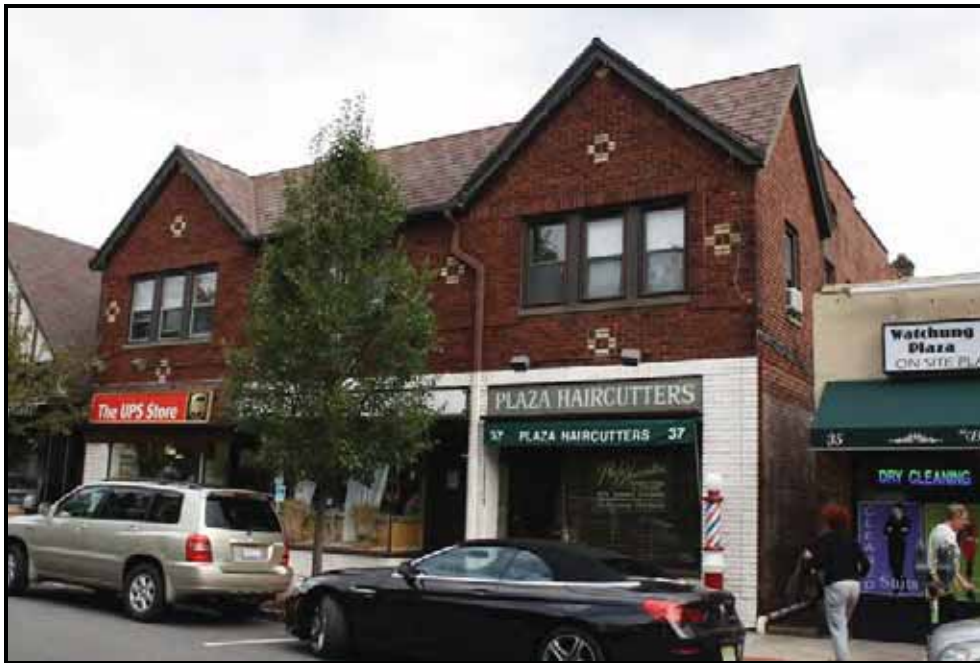
Architectural Description: This one-part commercial block has a side gable roof with crossing gables at either end, forming a false front to the shed-roofed building. The building has a patterned brick exterior; windows on the second floor are replacement sash with original stone sills. The building originally contained two stores but was later modified for three storefronts. Entries are recessed and contain wood doors with glazing. The display windows retain the molded frames and have brick bulkheads. The north storefront has a false mansard above the display window.

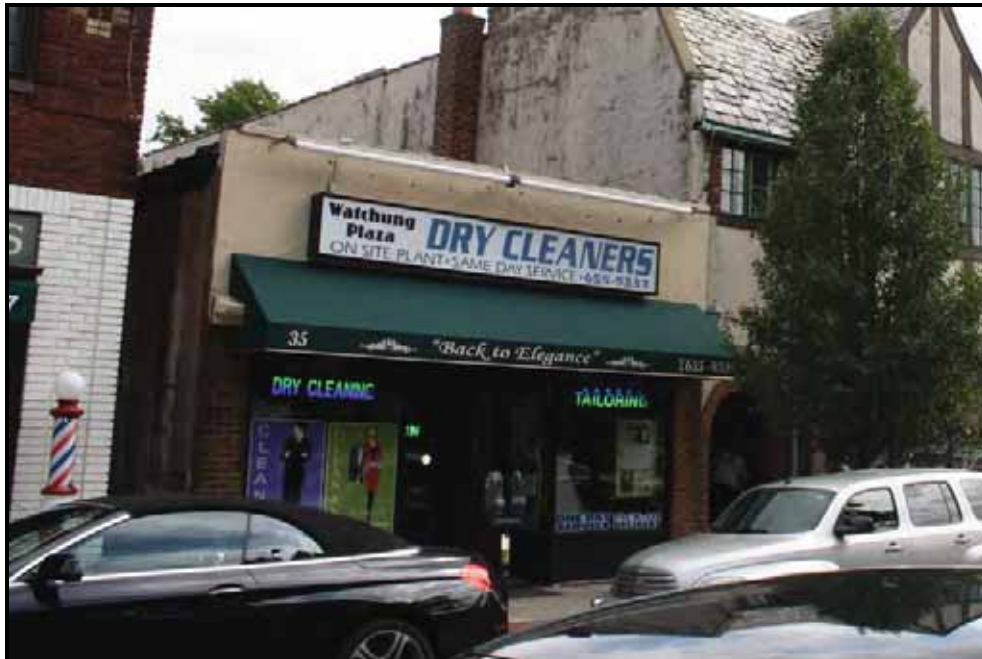
Architectural Description: This one-part commercial block has a brick facade that has been covered with stucco above the storefront. The central entry is recessed, and the windows and door are modern plate glass replacements with metal bulkheads under the display windows. The building has a fabric awning. Historic photos indicate that the building originally had a gabled parapet with a semicircular window above the storefront; the façade was altered after 1943.
